Above the Flood: Elevating Your Floodprone House

FEDERAL EMERGENCY MANAGEMENT AGENCY

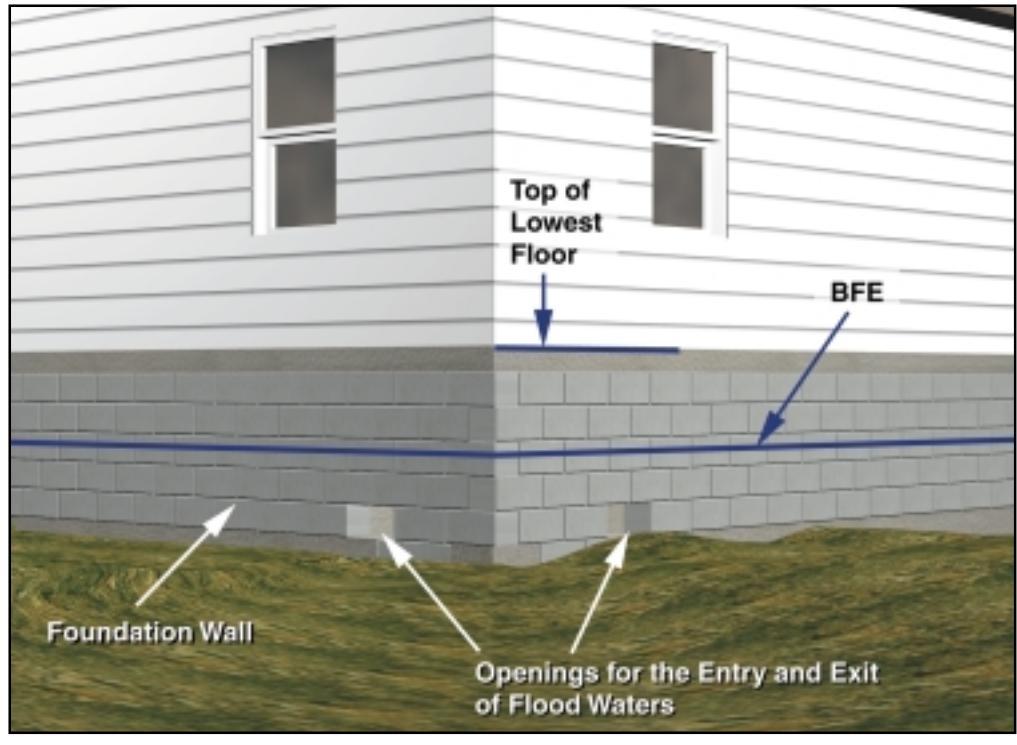
Figure 6

In a new, substantially improved, or substantially damaged building in an A zone, the elevation of the lowest floor must be at or above the BFE.

In A zones, where flood hazards are less severe, buildings may be elevated either on an open foundation or on continuous foundation walls below the BFE (Figure 6). Regardless of the type of foundation used, A-zone buildings must be elevated so that the **lowest floor** is at or above the BFE, as shown in Figure 6. If continuous walls are used below the BFE, they must be equipped with openings that allow flood waters to flow into and out of the area enclosed by the walls (Figure 6). Allowing the entry and exit of flood waters ensures that water pressures will be the same on both sides of the walls and reduces the likelihood that water pressure will cause the walls to fail.

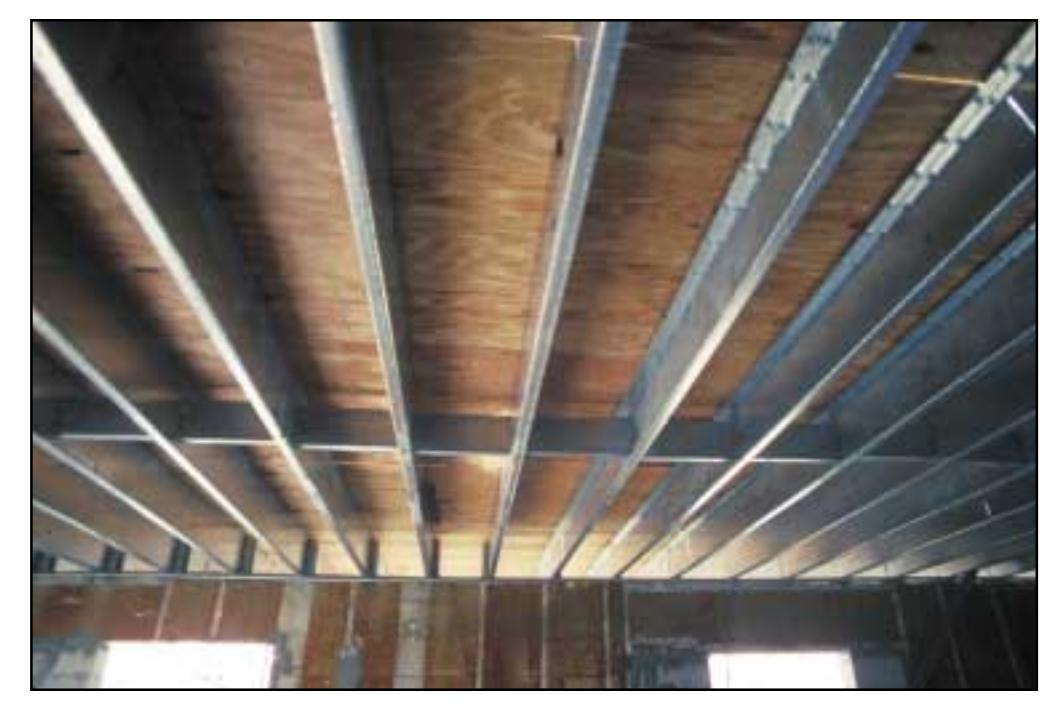
Figure 56

One advantage of metal framing is its relatively light weight. An additional advantage is that the screws used to attach metal-frame components provide strong connections.

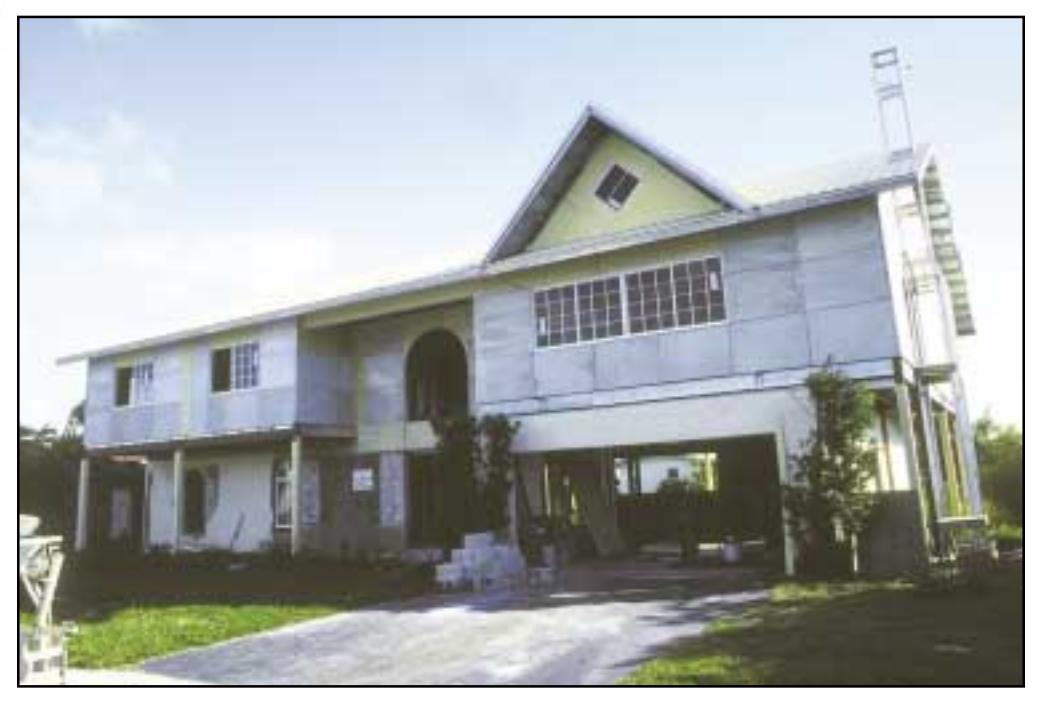
Figure 59

The exterior walls consist of prefabricated concrete panels. Innovative techniques such as those employed in this project are helping homeowners who need practical and economical methods of repairing and protecting their houses.

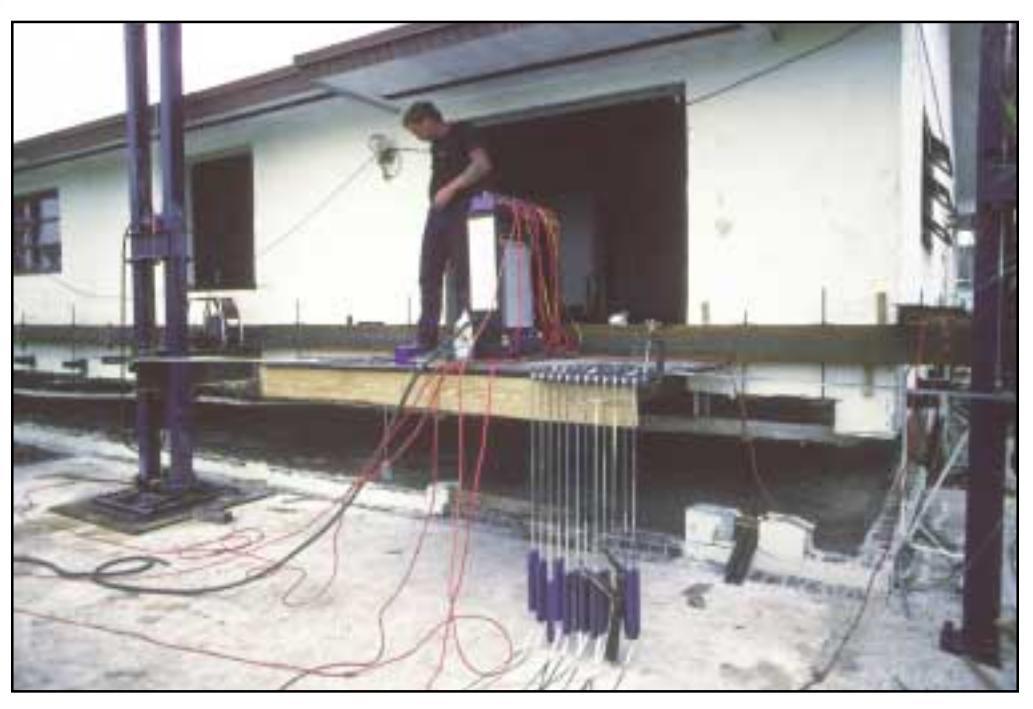
Figure 80

Lifting the house, while simple in theory, is complicated by the need to ensure an equal amount of lift at each jack throughout the process. Too much or too little lift at even one jack can cause the slab and walls to crack. The elevation contractor for this project used a sophisticated jacking system that provided the required level of control.
